Seiche Events on Lake Erie

Roy Widrig, New York Sea Grant

Kendra Vorenkamp, University at Buffalo

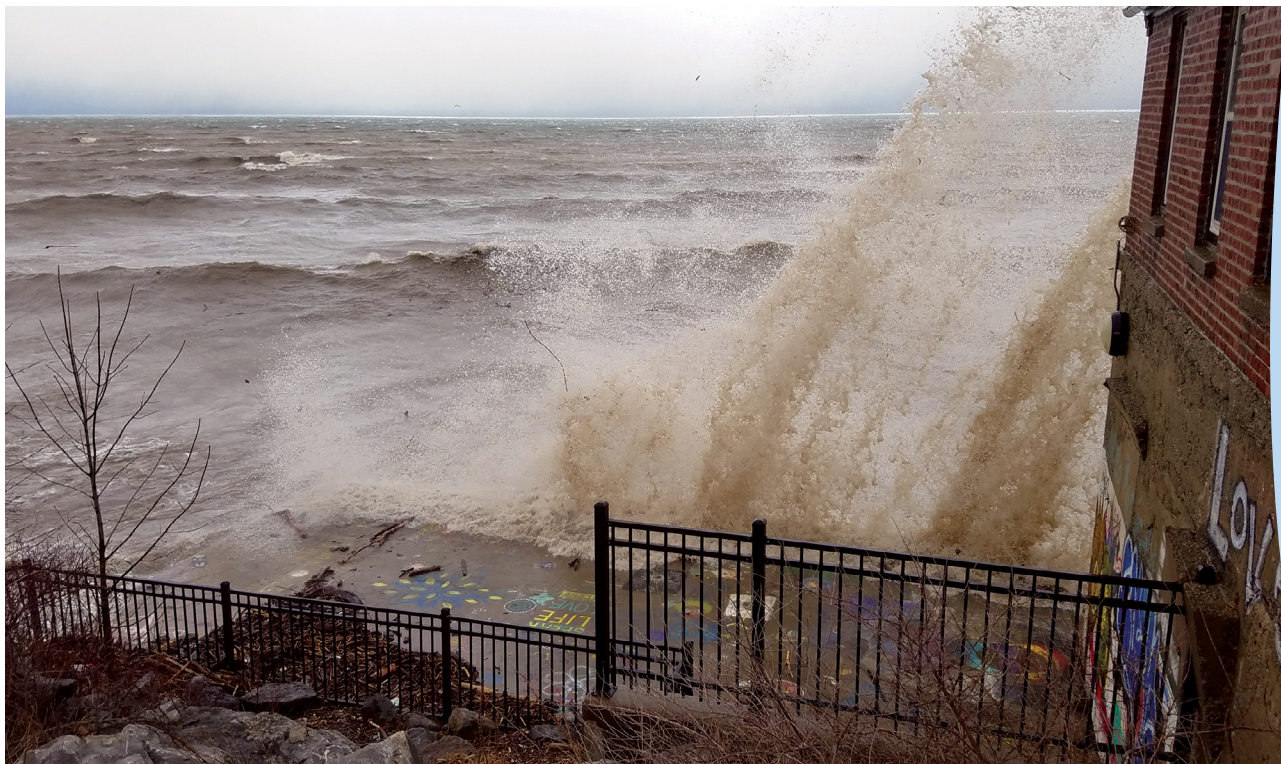
Seiche waves blast a shoreline structure in Buffalo, NY in April 2018. Photo by New York State Department of Environmental Conservation.

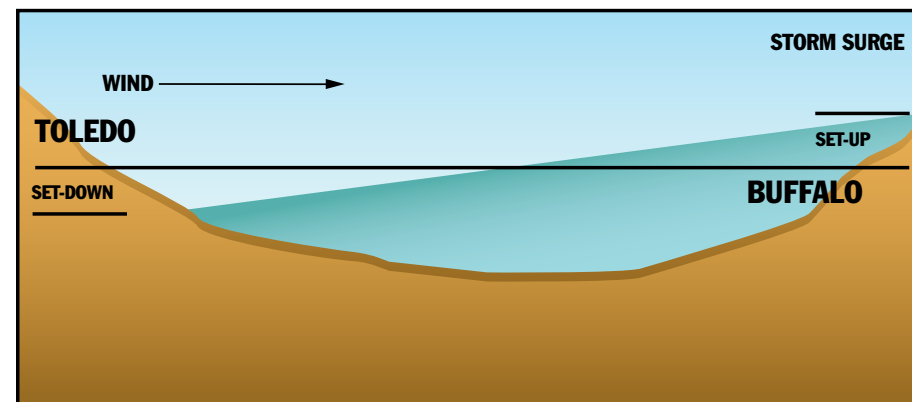
1A. During seiche events on Lake Erie, wind “piles up” water on the eastern shore of the lake, from Pennsylvania to Buffalo. At the same time, water levels on the eastern side near Toledo and Sandusky, Ohio, are pulled down.

A seiche (pronounced “saysh”) is a prolonged, standing wave oscillating through a body of water such as a lake or bay. Rapid changes in atmospheric pressure or high sustained winds from one direction, push up the water level at one end of the lake, while dropping by a corresponding amount on the opposite end. As the winds decrease, water rebounds to the drawn-down area and continues to oscillate back and forth, often for multiple days [See Figure 1A page 2]. These events are often associated with periods of high winds and fast-moving thunderstorms.

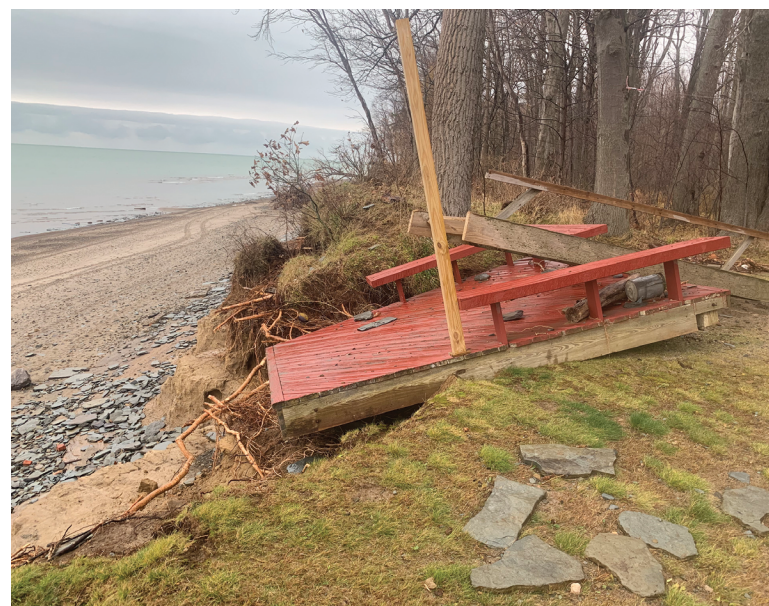
[Figure 2] Seiche-event shoreline damage submitted to New York Sea Grant from a property owner in Irving, NY. Waves produced by this seiche eroded the loose sediment above shale bedrock, undermining coastal structures and uprooting trees. Photo submitted through New York Sea Grant Virtual Site Visit form.
